Inspection Report

PROPERTY INSPECTION REPORT

Concerning: 6643 Autumn Sunset Lane, Spring, TX 77379

07/27/2011

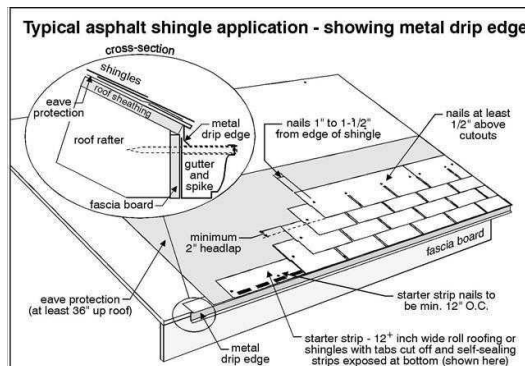
The first row of shingles was correctly sealed to the starter row, which prevent the shingles from lifting during high winds.

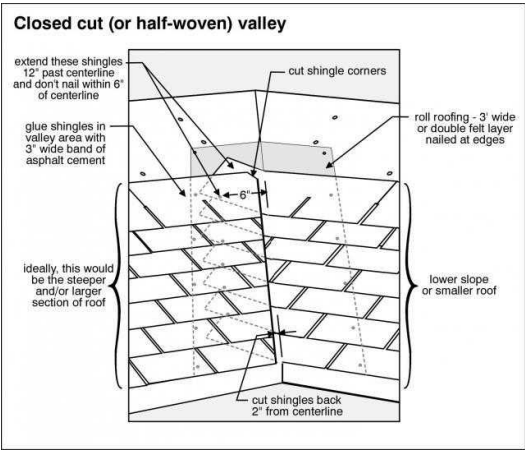
The cut edge of the valley shingles was sealed correctly, which prevent the shingles from lifting during high wind.

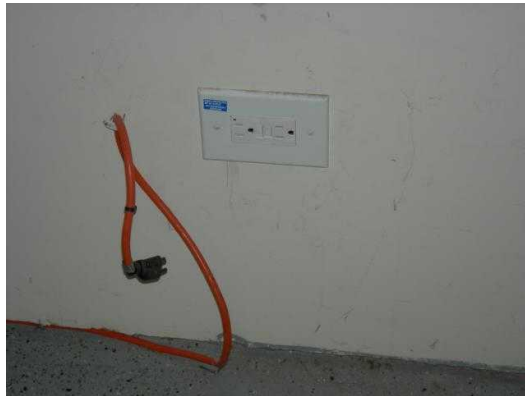
Extension cord used improperly as permanent wiring. Extension cords should not be used for permanent wiring due to fire safety concerns. Recommend installation of proper electrical wiring and receptacles to ensure safety by a licensed electrical contractor.

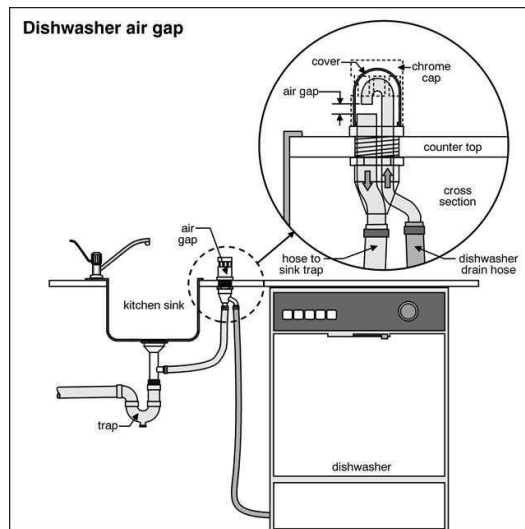
The dishwasher drain line has a high loop or an air gap is installed.
